ANALYTICAL RESULTS REPORT

RICO ARGENTINE
Rico, Dolores County, Colorado

**ANALYTICAL RESULTS REPORT for
EXPANDED SITE INSPECTION**

**Rico-Argentine
Rico, Dolores County, Colorado**

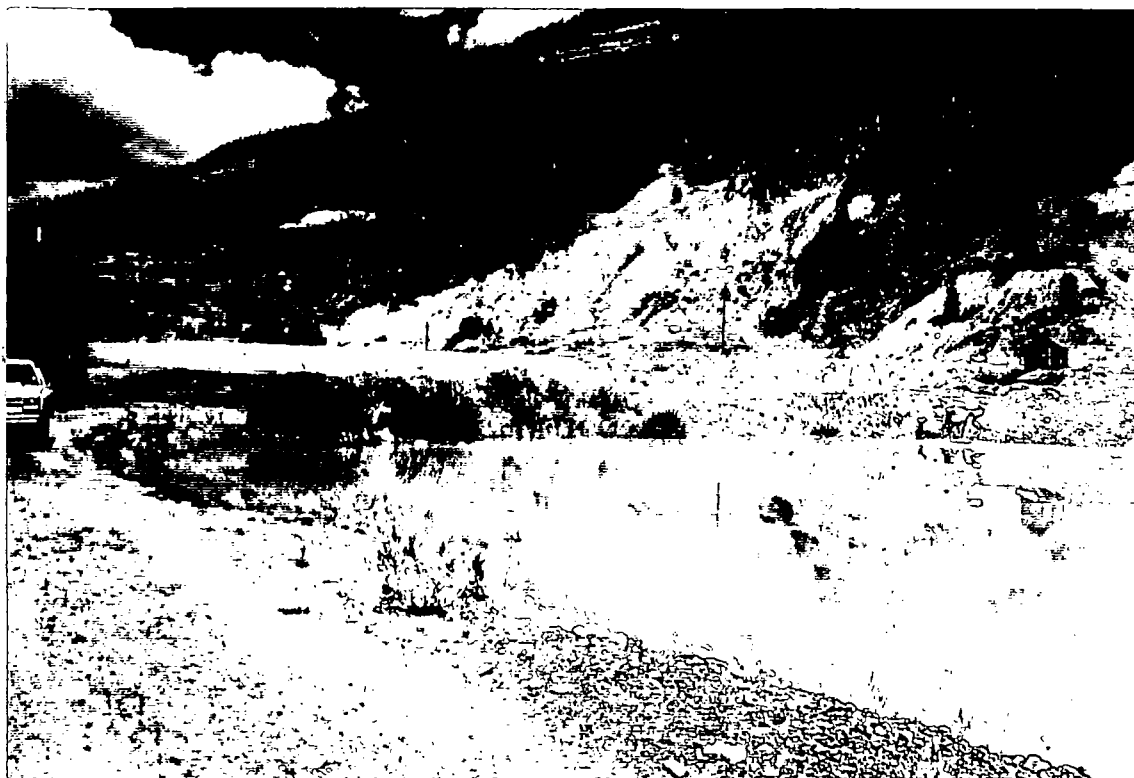
PHOTO 1

Sample location RA-WSW/WSE-01. St. Louis Tunnel. Uppermost of settling ponds. Outfall is in the upper right corner under the little shack. Water in the pond is about six to eight inches deep. Iron staining is from sediment.

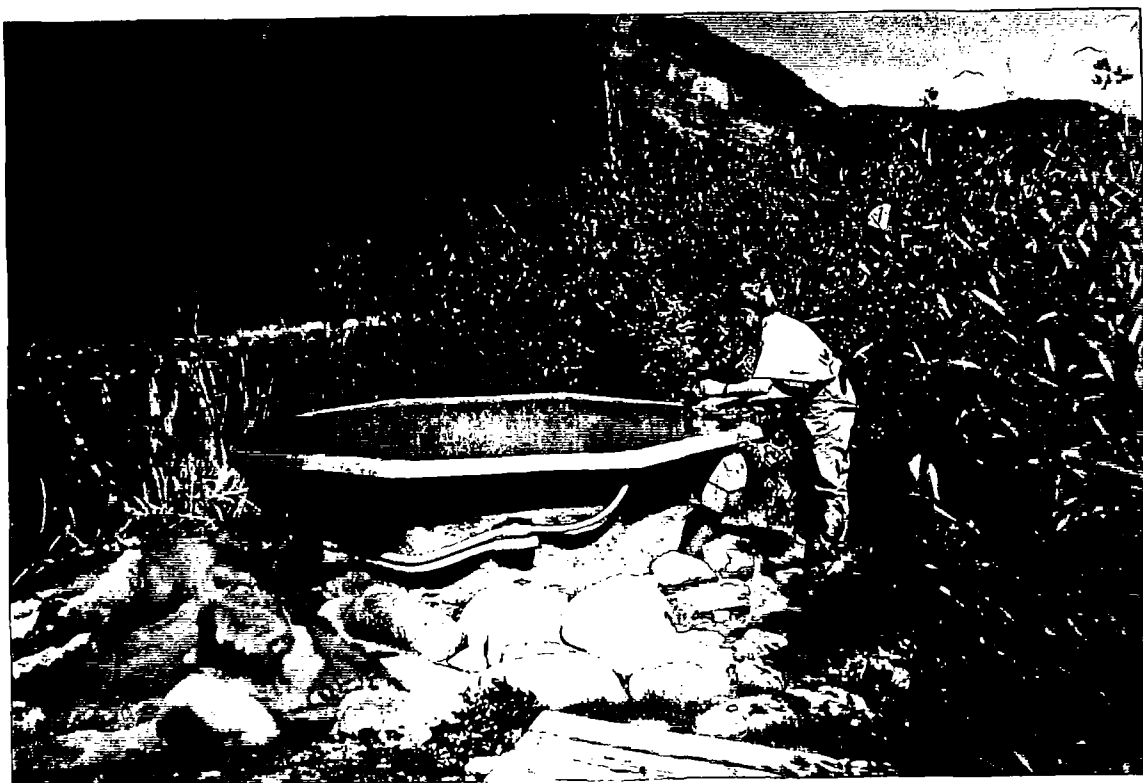
PHOTO 5

R. Badger taking sample RA-WGW-02 from PVC pipe leading into the community-use hot tub. Note the iron oxide stained carbonate deposits around the tub.

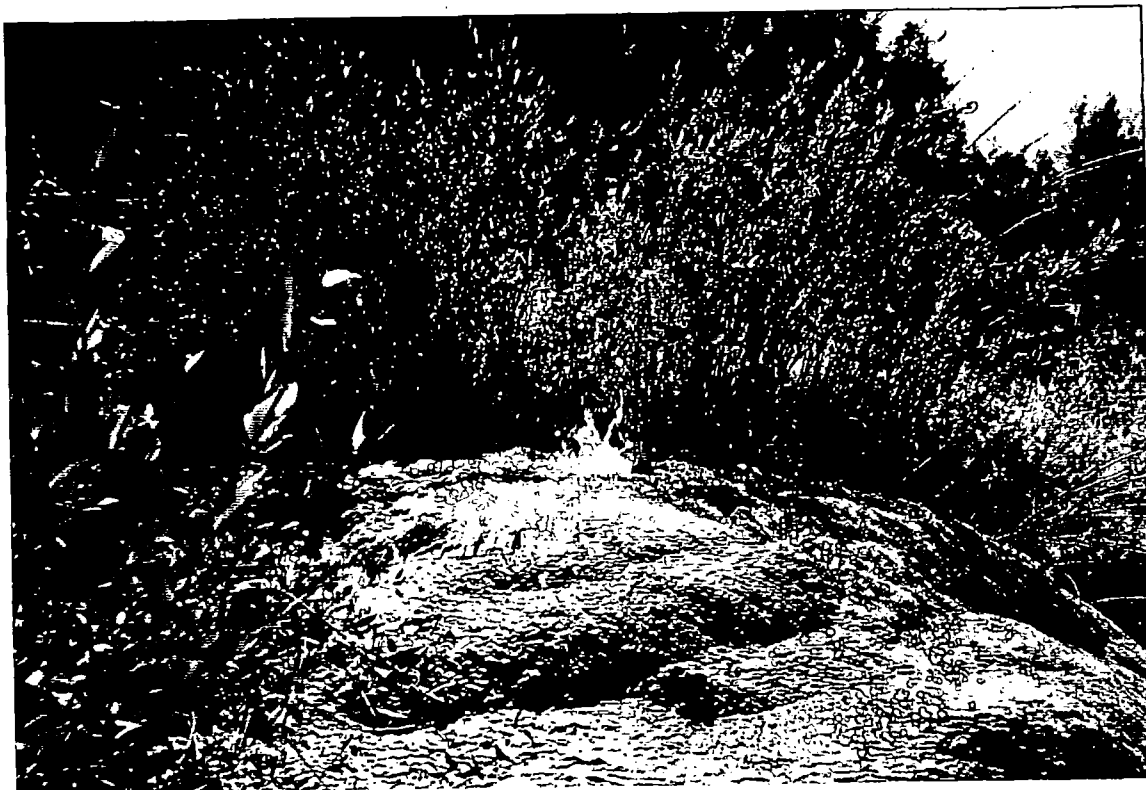
PHOTO 6

Second hot spring from the hot spring area. Note water is forcibly ejecting. Flow is about 15 to 20 gallons per minute. Note iron stained carbonate deposits.

Field water quality readings were taken and flow estimated for the two subaerial thermal springs located at the site (Table 2). Similar water quality parameters indicate a common source. Several other hot springs were noted to be bubbling through ponds located south of the settling ponds.

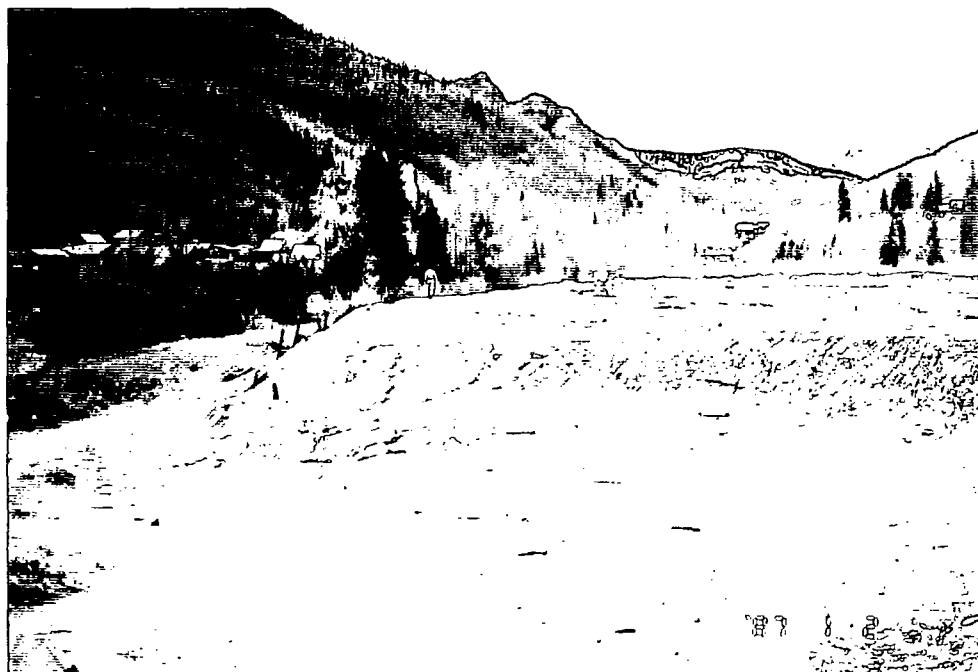
PHOTO 12

View of tailings pile at RA-SW/SE-08 just south of town of Rico. Dolores River is on the left side of photo where it is actively eroding the tailings. Tailings were sampled as RA-WSO-06.

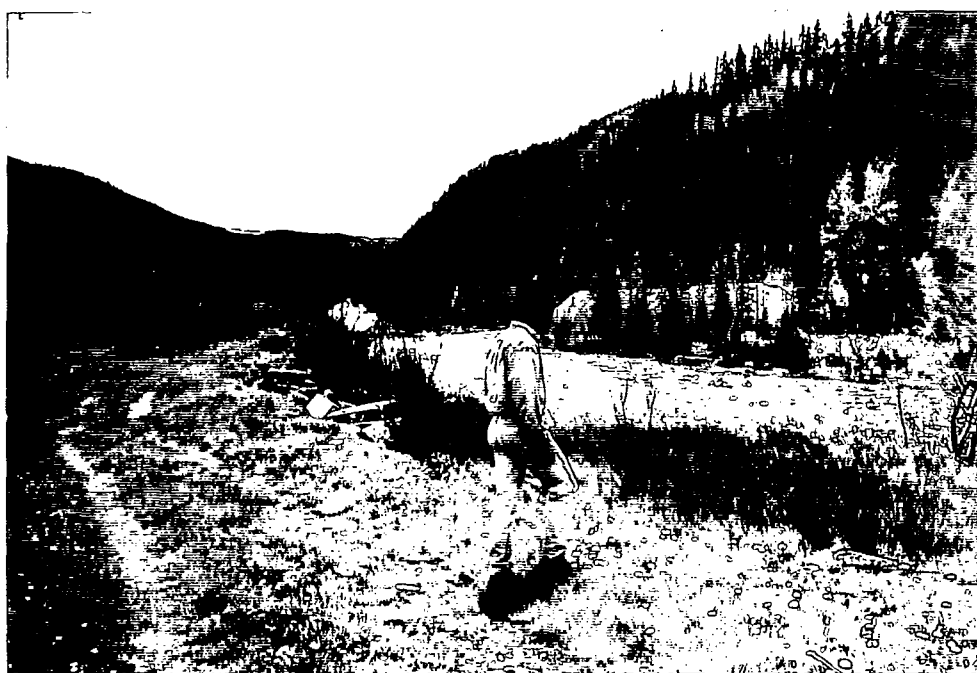
PHOTO 13

View to south along Dolores River of tailings pile split by Dolores River at RA-SW/SE-09. Tailings on left (east) side of river were sampled as RA-WS0-09.
